**EXAMPLES OF DAMAGE CAUSED BY TOP FRAME ISSUES**

**THESE ISSUES ARE NOT ELIGIBLE FOR "DEFECTIVE ITEM" CLAIMS OR COVERED BY OUR WARRANTY**

**ARO PATTERN #259 1968-72 GM A-BODY CONVERTIBLES**

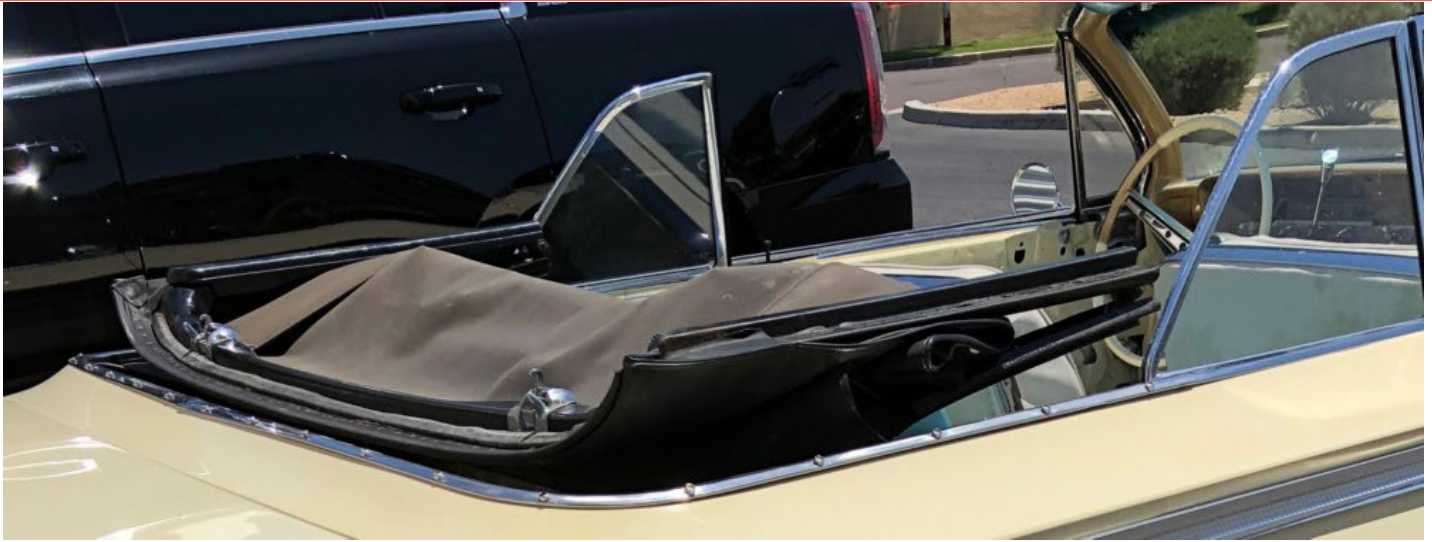
**THE PHOTO BELOW SHOWS HOW OUT OF ADJUSTMENT THE TOP FRAME WAS BEFORE THE FIRST INSTALL. TOP FRAME WAS UNABLE TO FOLD ALL THE WAY DOWN**

**CUSTOMER INSTALLED FIRST TOP - WHICH PUNCTURED THE SIDE ON DRIVERS SIDE WHILE FOLDING DOWN. OWNER COMPLAINED THAT THE "ZIPPER CAUSED A PUNCTURE" BUT THE ZIPPER PULL WAS 12" AWAY FROM THE PUNCTURE MARKS CREATED.**

**TOP FRAME WAS ADJUSTED, CUSTOMER INSTALLED SECOND TOP - PINCHED PASSENGER SIDE QUARTER DAMAGED BY UNKNOWN CAUSE.**

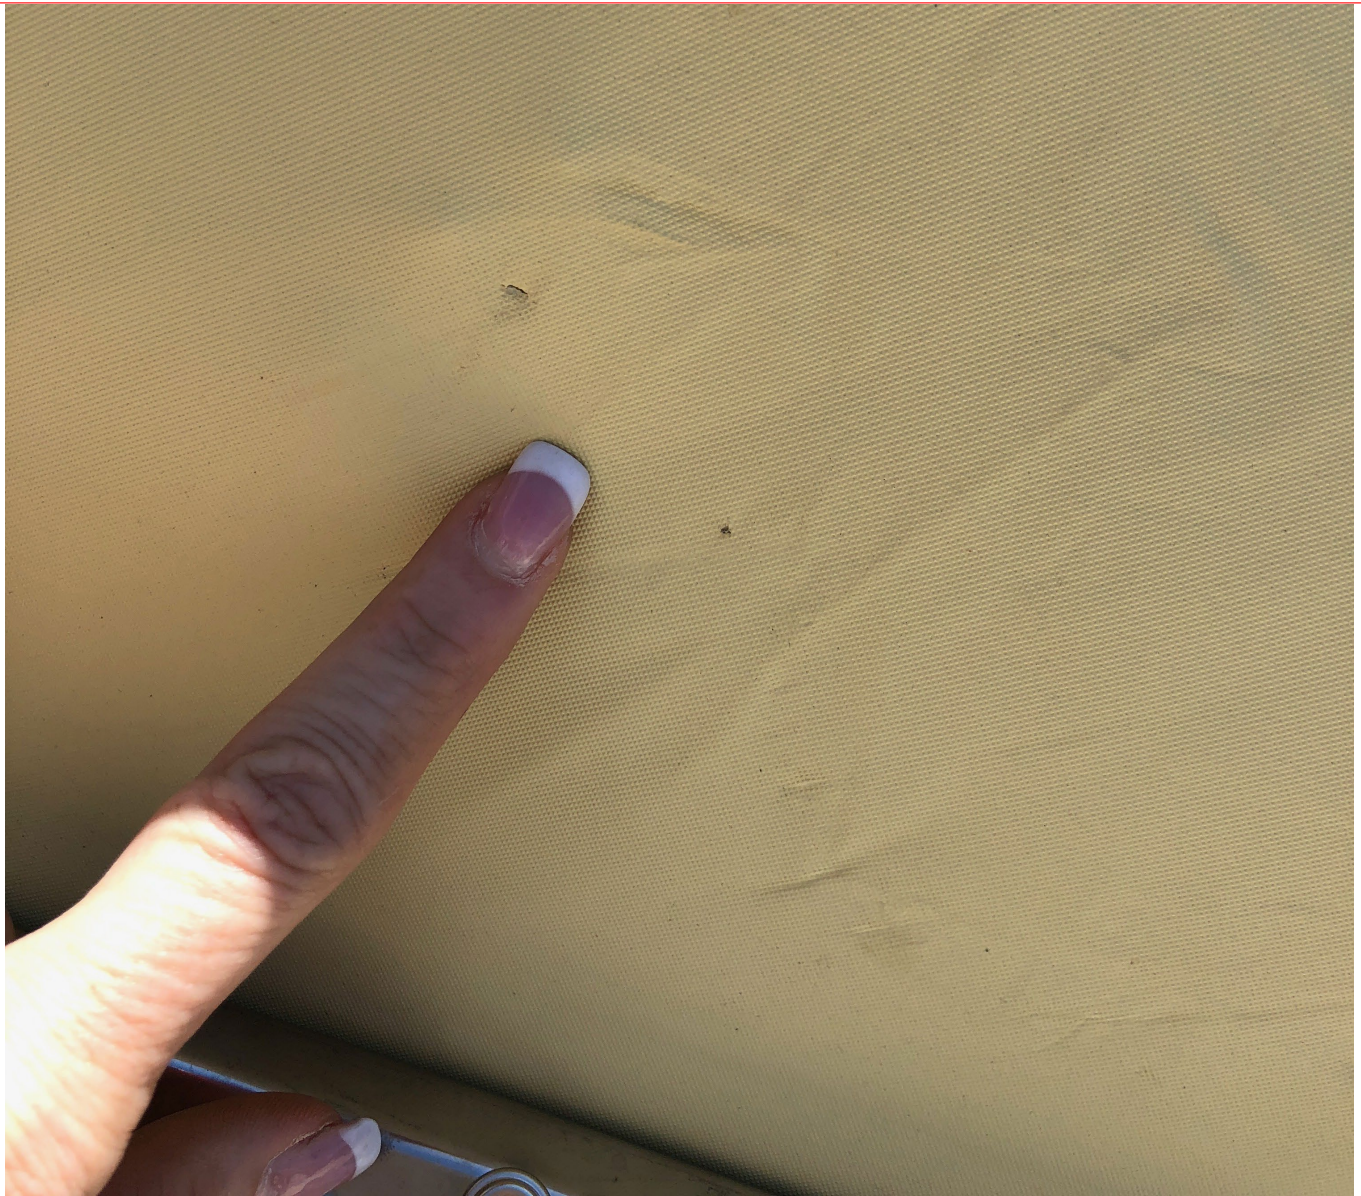
**1st TOP INSTALLED  
DRIVERS SIDE DAMAGE  
COMPRESSION DAMAGE CAUSED BY FRAME MISALIGNMENT WHILE FOLDING DOWN**

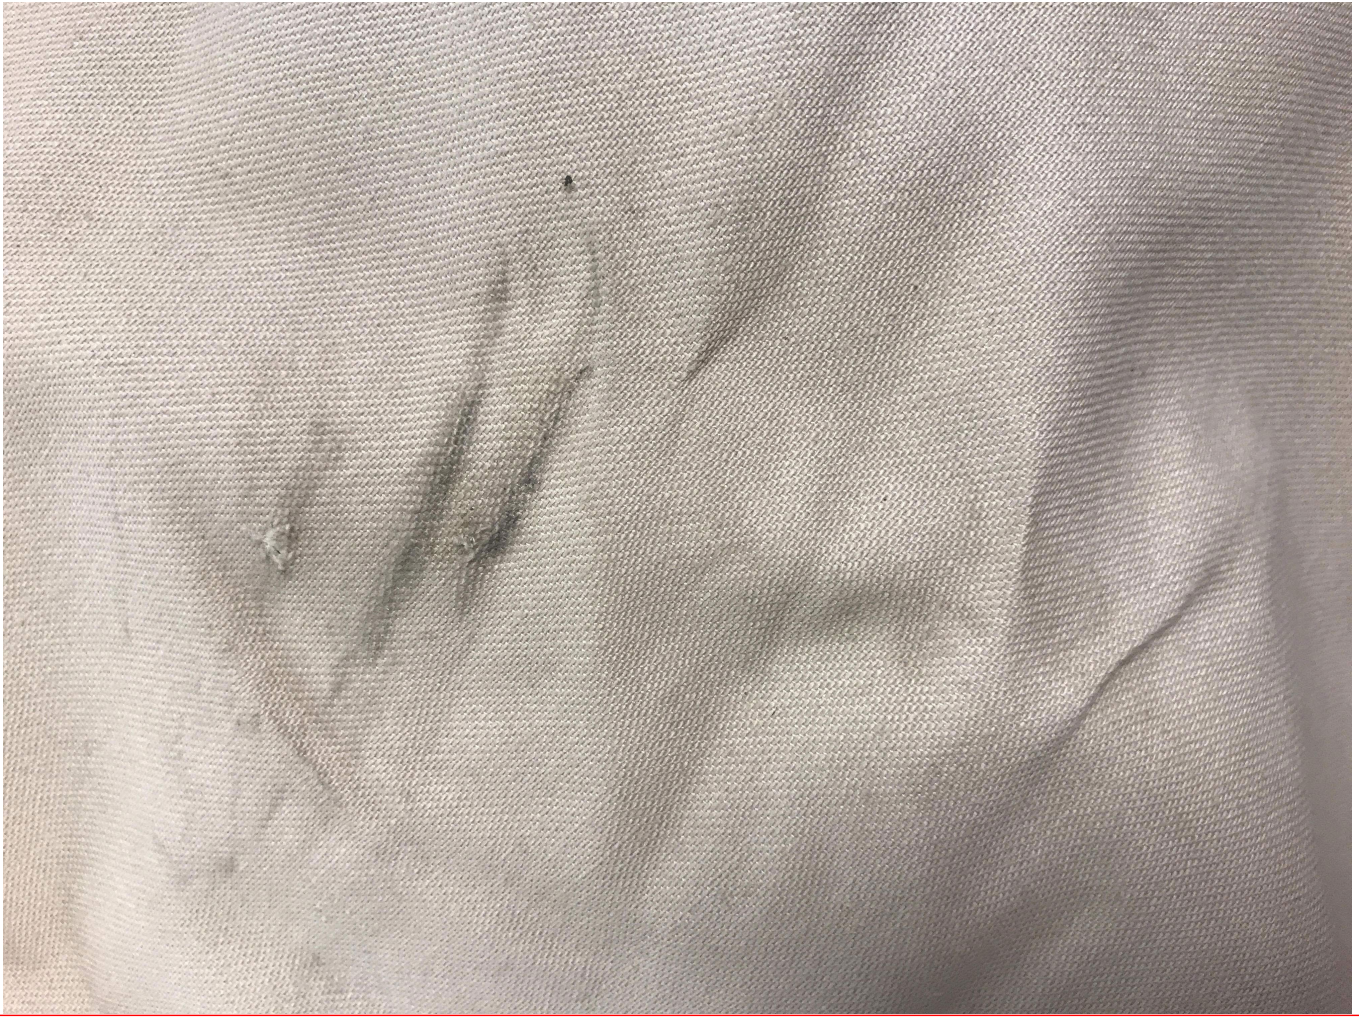
***1st TOP INSTALLED  
DRIVERS SIDE DAMAGE - INTERIOR DAMAGE EVIDENT  
COMPRESSION DAMAGE CAUSED BY FRAME MISALIGNMENT WHILE FOLDING DOWN***

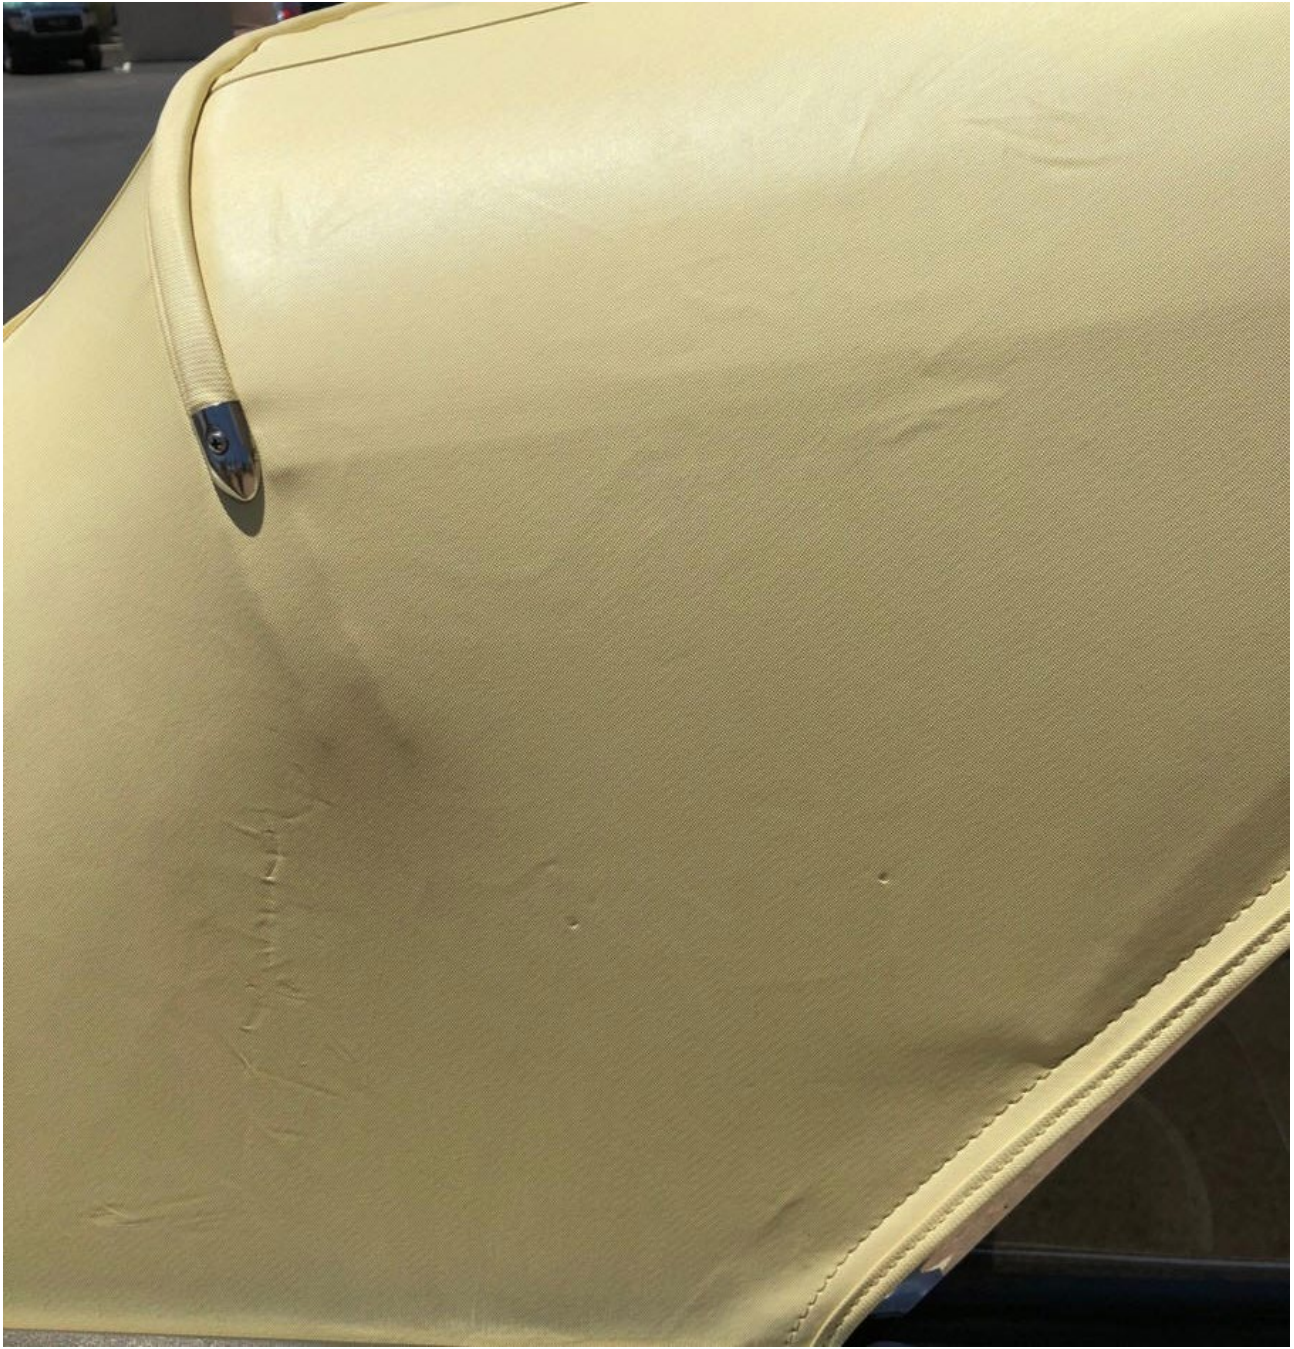
**2ND TOP INSTALLED  
THIS TIME - PASSENGER SIDE DAMAGE  
COMPRESSION DAMAGE CAUSED BY FRAME MISALIGNMENT WHILE FOLDING DOWN**

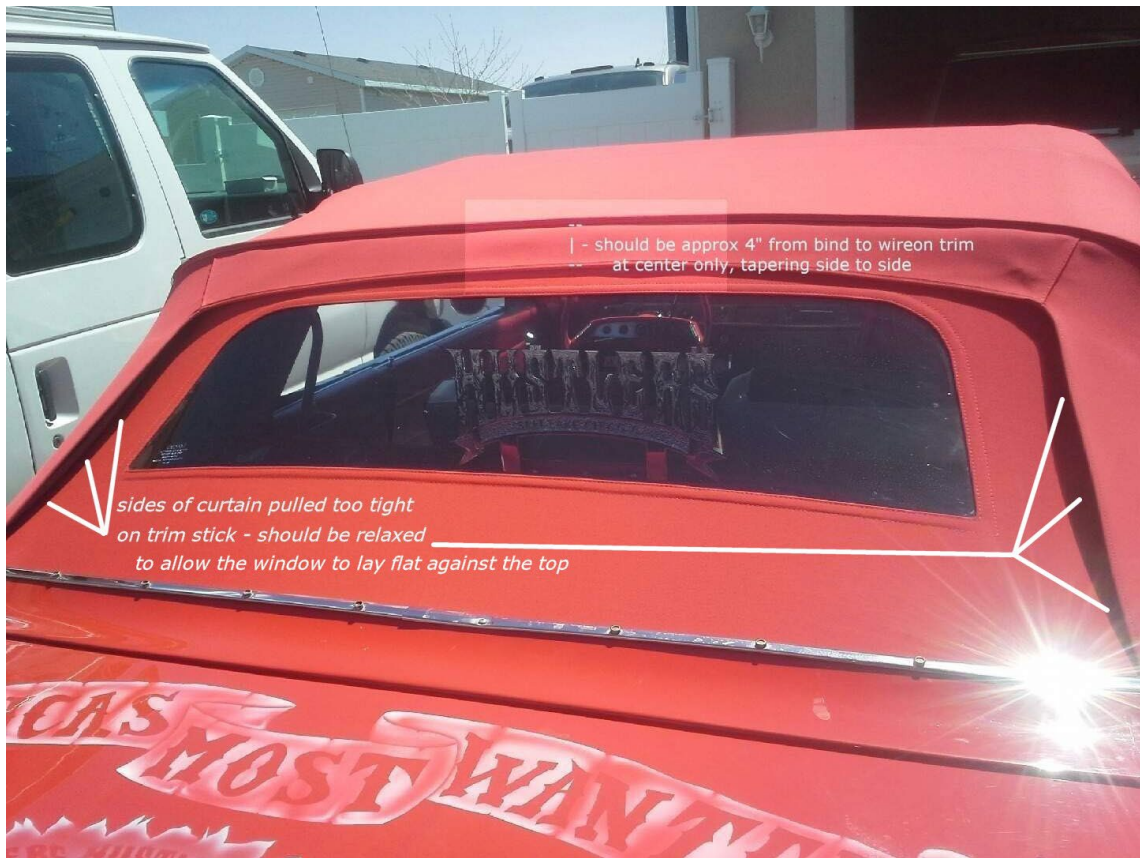
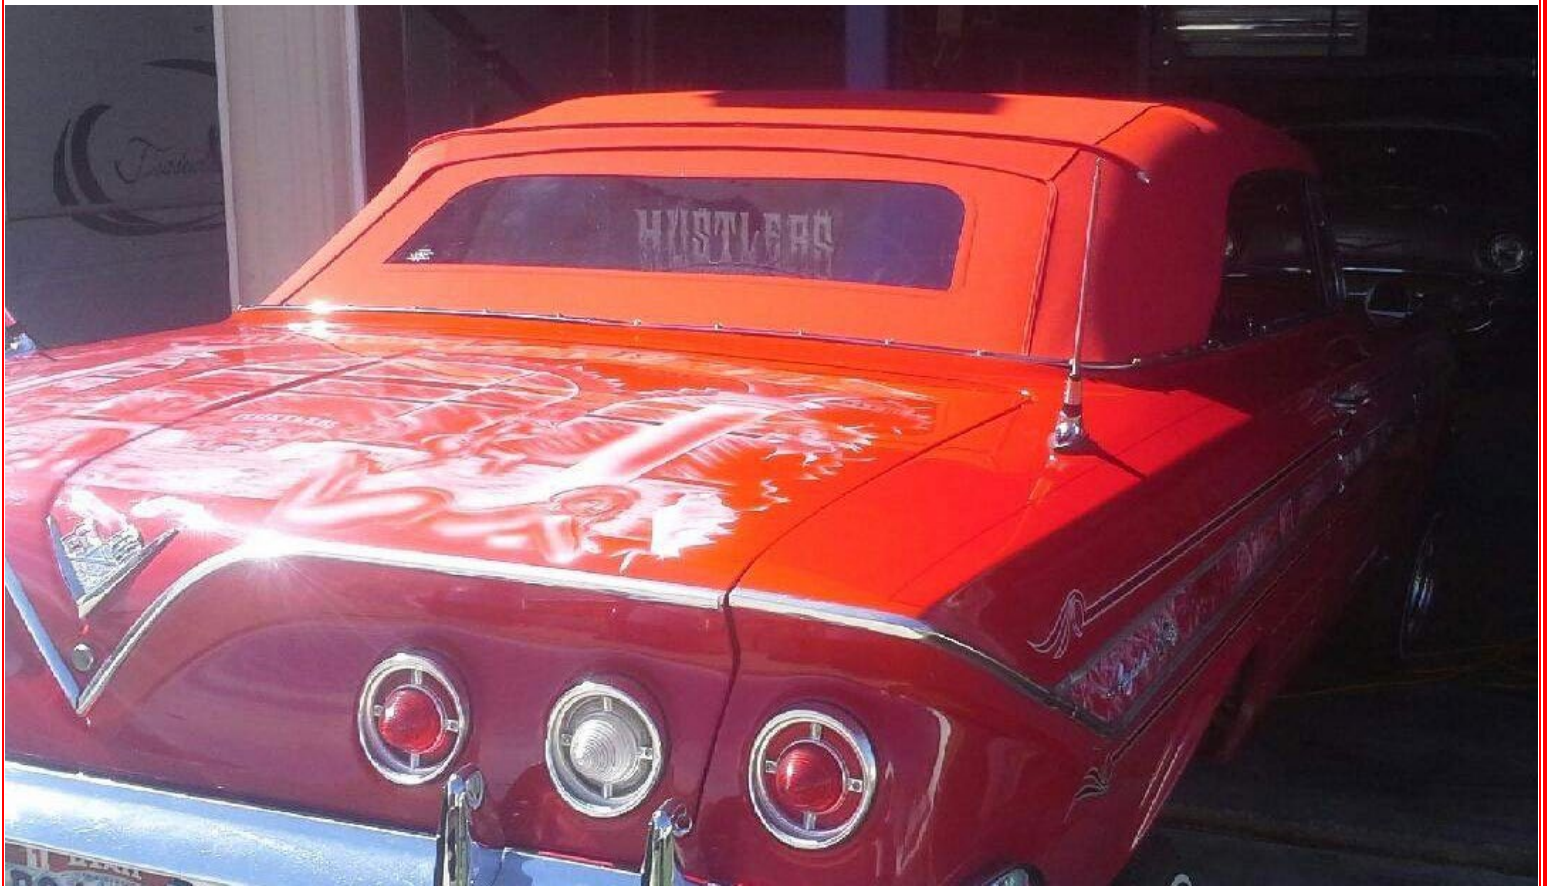
***THE TOP WAS FINISHED ACROSS THE FRONT BEFORE THE WIREON TRIM WAS INSTALLED - PULLING THE CENTER OF THE VALANCE TOO FAR FORWARD. THE REAR DECK SHOULD HAVE HAD A FEW STAPLES ACROSS THE REAR BOW TO POSITION THE VALANCE PROPERLY BEFORE FINISHING THE FRONT.***

***THE WINDOW CURTAIN WAS PULLED TOO TIGHT DOWN ON THE TRIM STICK AND IS PULLING AWAY FROM THE SIDES OF THE TOP. THE SIDES OF THE CURTAIN COULD BE RELEASED AND RESET IN ORDER TO "RELAX" THE MATERIAL AND ALLOW THE CURTAIN TO LAY AGAINST THE SIDES OF THE TOP. (SEE BOTTOM PICTURE AFTER ADJUSTMENT)***

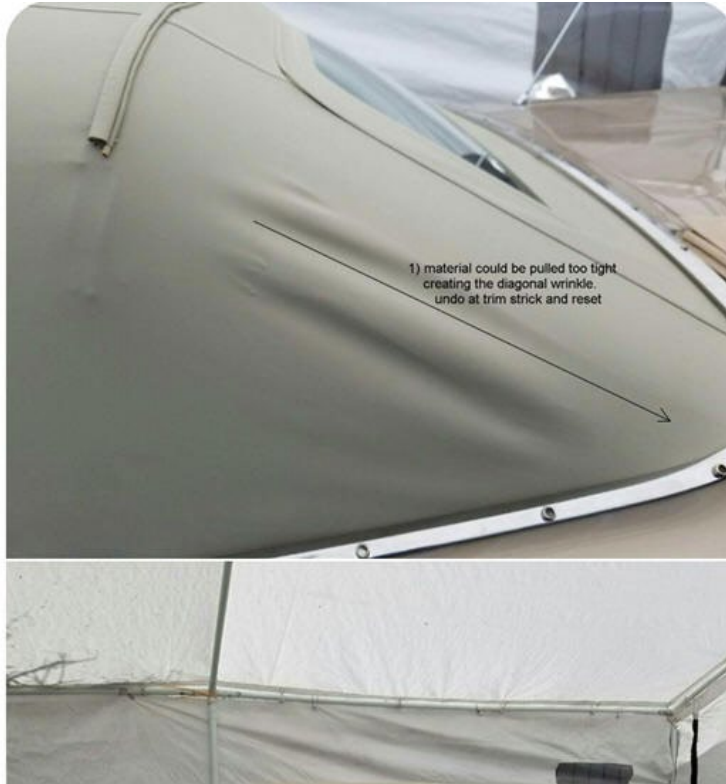
**DIAGONAL WRINKLES IN REAR QUARTER PANELS COULD BE CAUSED BY PULLING TOO TIGHT AT TRIM STICK. RELEASE THE MATERIAL AND RESET. USE A TRIM STEAMER.**

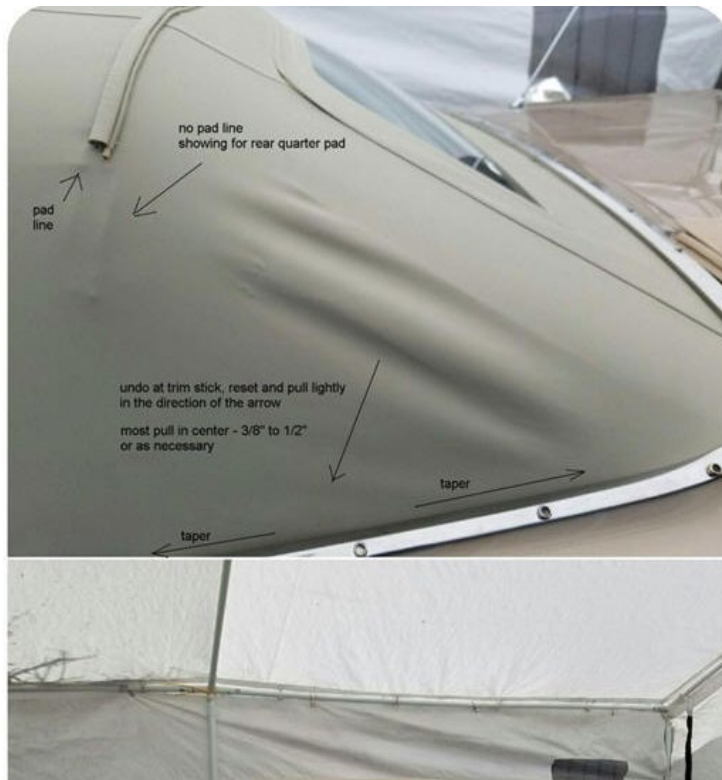
**THE DIAGONAL WRINKLE CAN BE READJUSTED OUT AS SHOWN IN THE DIAGRAM. HOWEVER, IF THE REAR QUARTER PADS ARE NOT INSTALLED, ADJUSTMENT WILL BE DIFFICULT AND NOT PROVIDE A SATISFACTORY SOLUTION DUE TO INCREASED INSTALLATION TIMES. UPPER PAD LINES CAN BE SEEN THROUGH THE MATERIAL.**

**NO EVIDENCE OF REAR QUARTER PADS IN THE CORRESPONDING AREA.**

**(THE INSTALLER SAVED 15 MINUTES BY NOT INSTALLING THE REAR QUARTER PADS. HE WILL SPEND AN HOUR OR MORE MAKING ADJUSTMENTS TO ELIMINATE THE WRINKLE).**

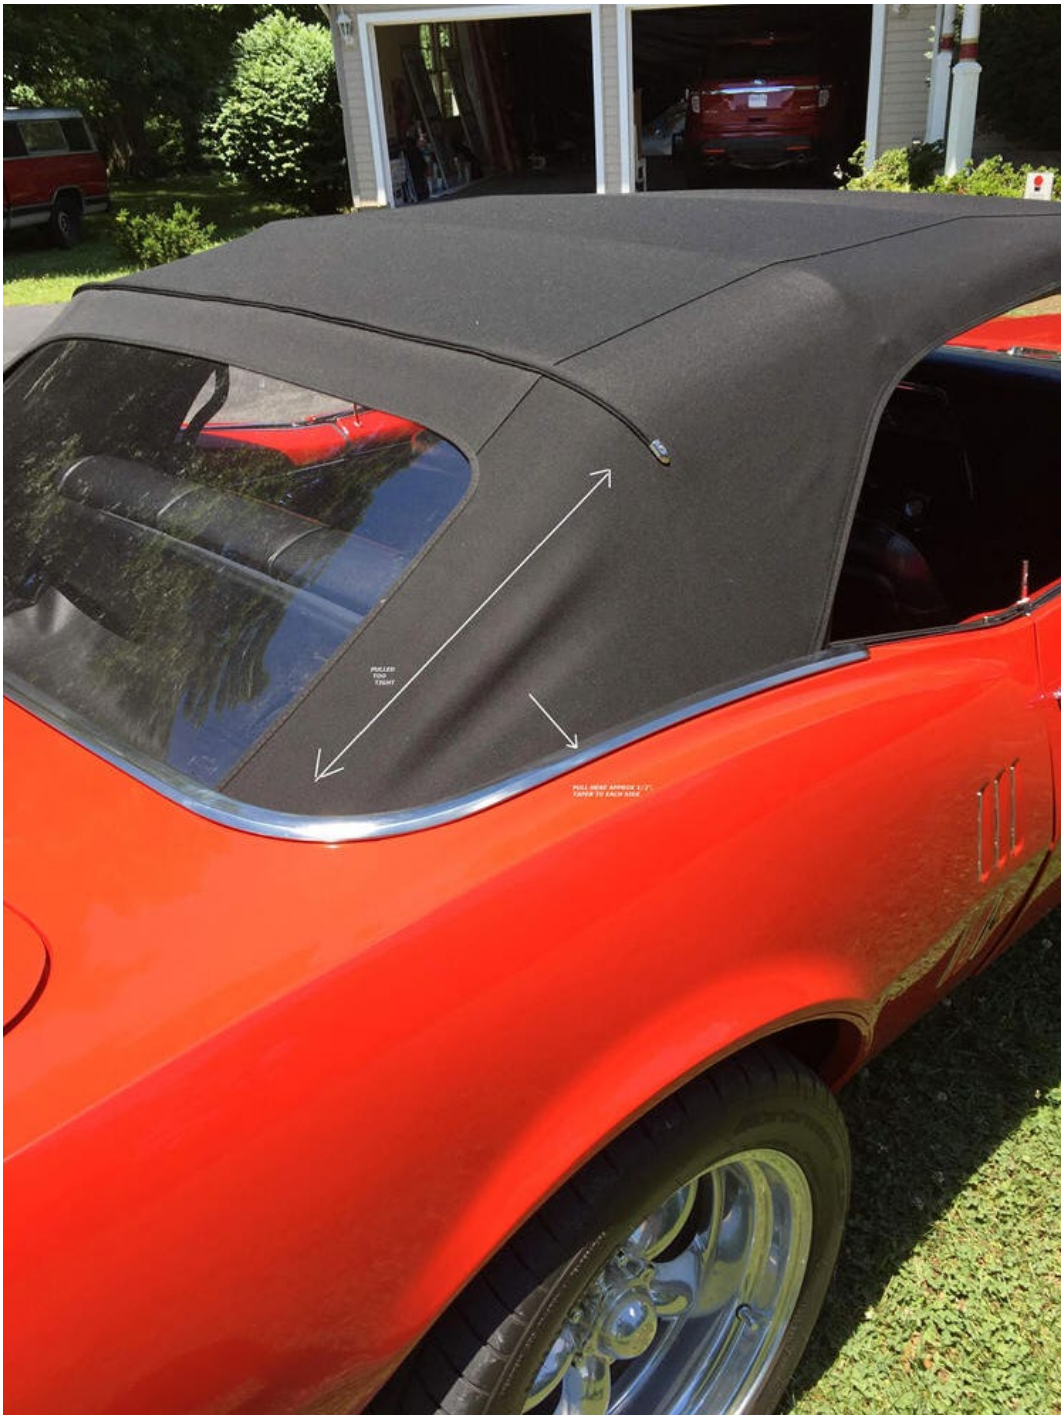
**1967-69 CAMARO/FIREBIRD BELOW WITH SIMILAR ISSUES, EXCEPT IT DOESN'T REQUIRE REAR QTR PADS**
