TRANS GO[®]

LOCK UP KIT[™]

200C

FIXES: LOST LOCKUP CONTROL

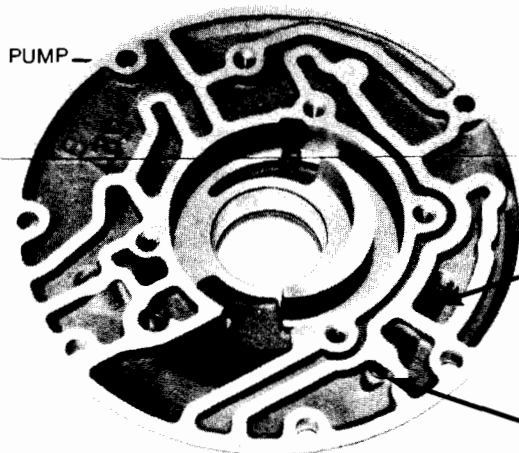
ADVICE: Do not remove the thimble filter to replace it or clean it. Just blow at it good with your air gun. It is very unlikely that it would be clogged enough to keep it from flowing enough oil thru the .033 orifice in the cup plug.

ADVICE: Do not attempt to remove the orificed cup plug unless you are sure the thimble filter has to be replaced. The orifice in this plug is .030-.035—If you have enlarged the hole, you will have all time lockup.

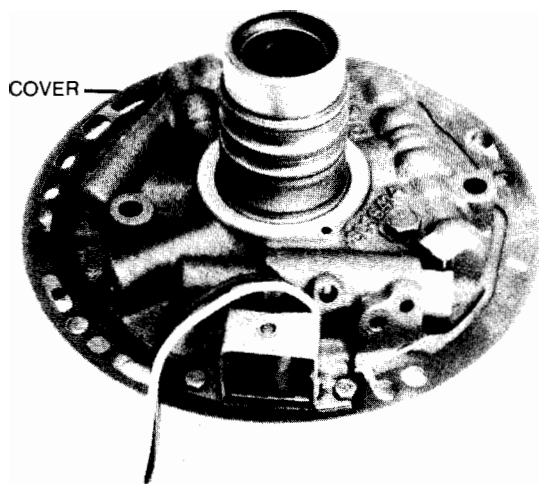
PARTS FURNISHED IN LOCKUP KIT[™]
REPLACE O.E.M. PART NOS.:
