48-PLT-01

**Improved 4L80E VB Plate
Tougher and Zinc plated.**

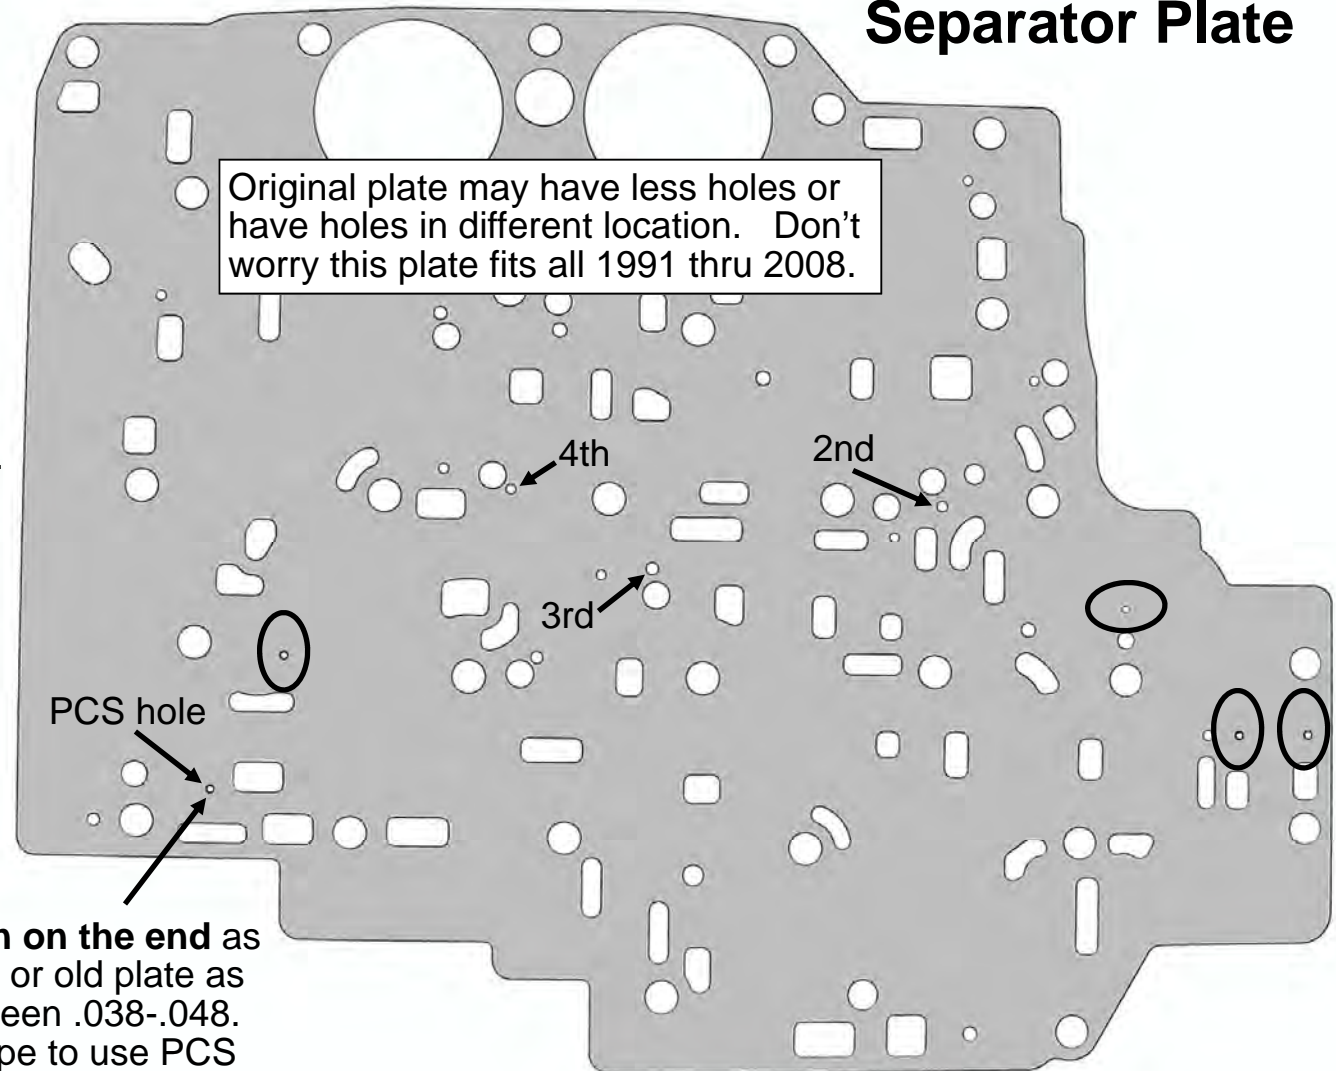
Separator Plate

You may find one or more of the shift feed holes are smaller than original plate, especially on 91-92 models.

ALWAYS check holes ***circled*** to make sure they are in the plate.

Plate furnished does not have PCS Balance hole.

IF the PCS solenoid has a screen on the end as shown on next page, use gasket or old plate as guide and make a **PCS hole between .038-.048. Also, VB **must** be NON-Vented type to use PCS solenoid with a screen on the end.**

If they are not in the plate center punch and drill them .031 (1/32") or .039 (1mm) using the gasket as a guide.

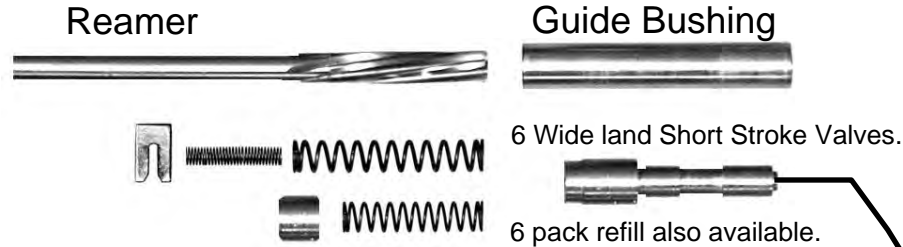
48-ACT-TL Kit: Fixes 6 Valve Bodies.

Actuator Valve Bore Wear:

Pressure OK COLD and LOW when HOT.
Clutch—Band—Converter Slip, Wrong gear starts, mysterious burn up. Codes 39, 85, 68 PO757, 894, 730.

Look CAREFULLY for WEAR:

Remove spring. Move valve back about 3/16" from bottomed while feeling for up/down or side to side wiggle.

Order 48-ACT-TL repair kit.
Fixes 6 valve bodies.

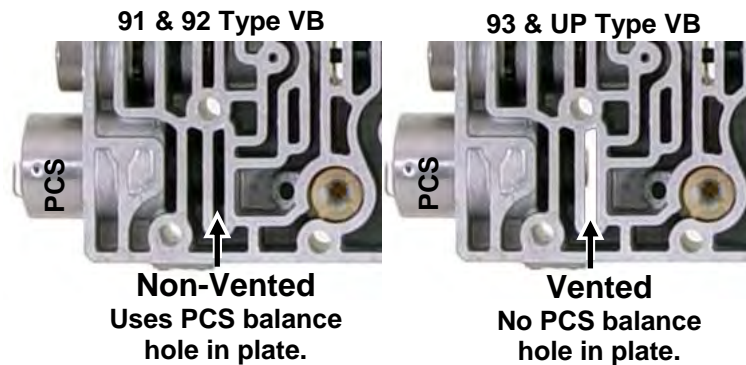
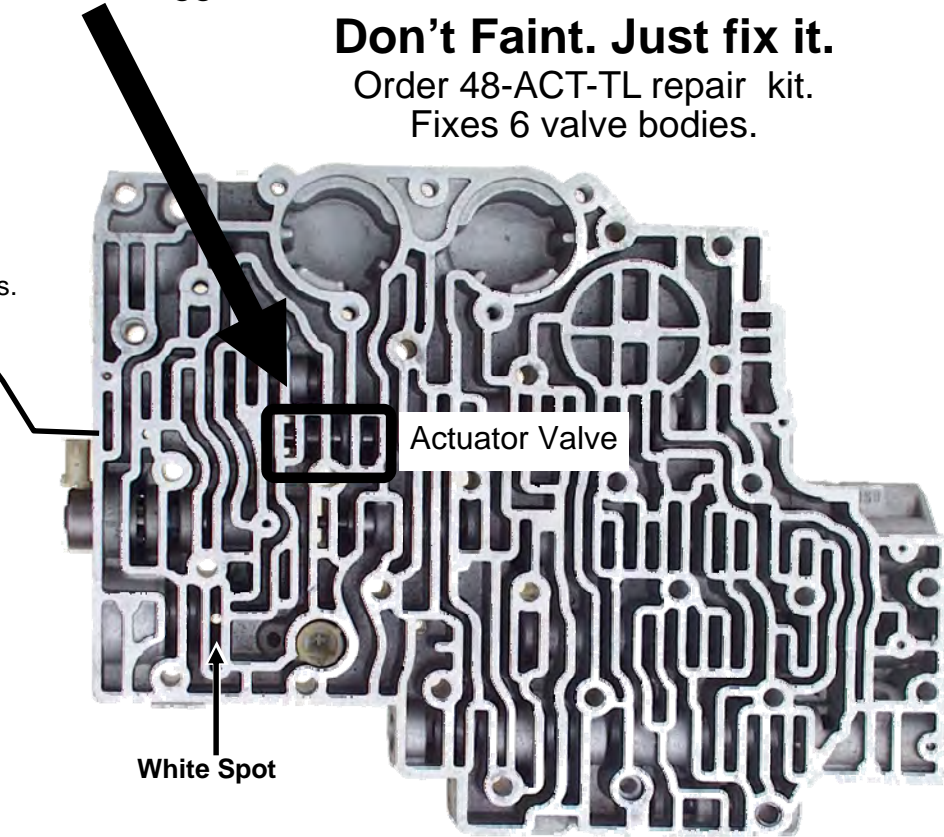
Plate, VB and PCS Solenoid Matching:

Early PCS w/screen

Screen on this end: Requires 91 & 92 Non-Vented VB with PCS hole in plate.

No Screen on this end: Ok on all models. Normally found with 93up Vented VB and no Balance hole in plate.

.038-.040 PCS Balance hole is ONLY required on VB's when using a Pressure Control solenoid that HAS a Screen ON THE END and a Non-vented VB!

With Screen PCS solenoid: Plate must have .038 to .048 PCS hole and NON-Vented VB.

Without Screen PCS solenoid: Plate must not have PCS hole and must have Vented VB or make a vent by drilling an exhaust hole .093 to .130 thru bottom of passage at white spot shown above.
