SK® C3

Corrects/Prevents/Reduces

Front Band Failure, Soft 1-2, Late 2-3, Delayed Reverse, Shuttle Shifting and Excessive Passing Gear.

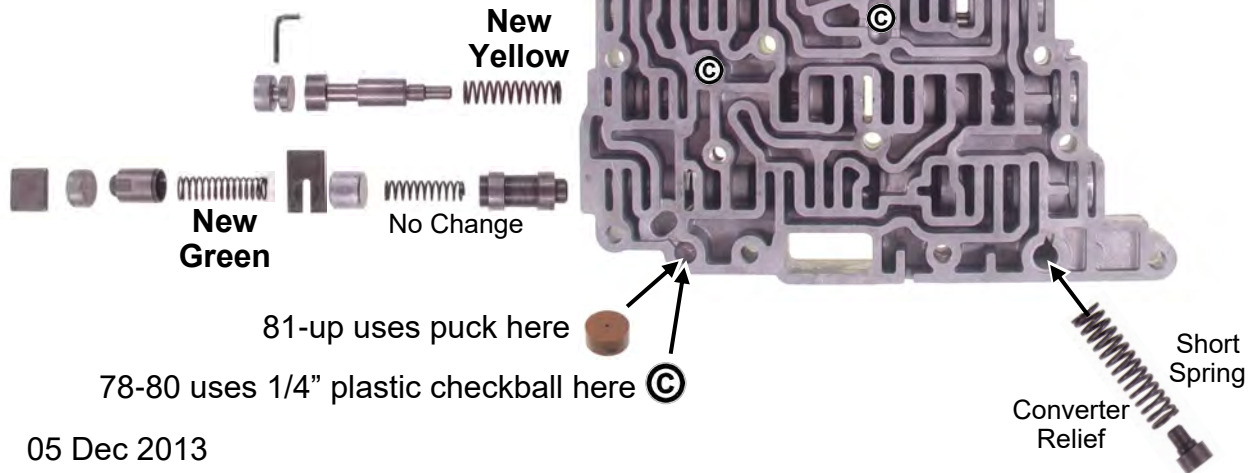
Tip: For smoother, earlier shifts install modulator pin provided. Its longer than the original.

Step 1: Install new Springs shown in **Bold**. Re-use check balls, puck (if applicable) and Relief Valves and Springs.

Step 3: Adjust front band 10-12 inch pounds (snug with a short wrench and back off 1.5 turns & tighten locknut.

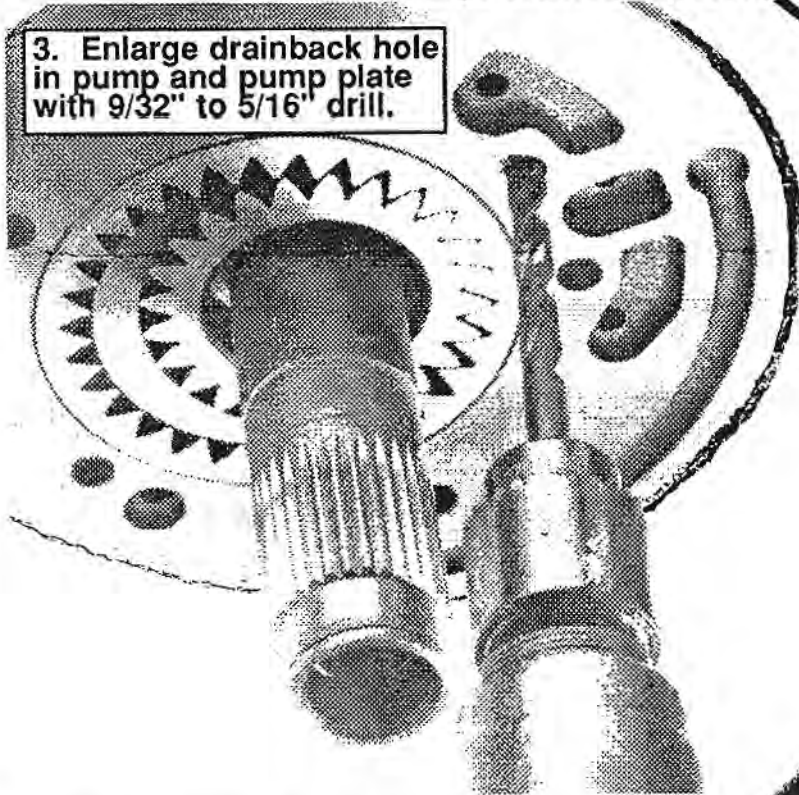
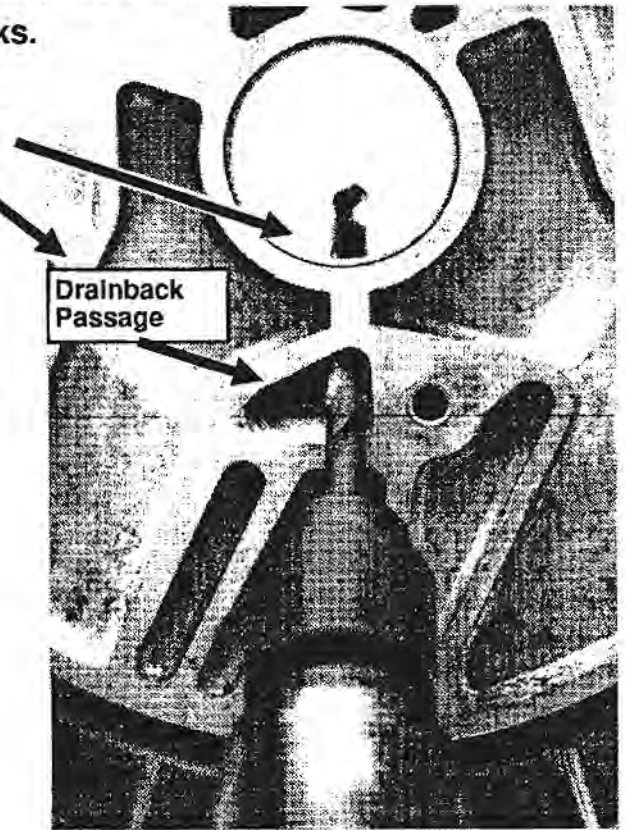
COMPLAINT: Front seal blows out, lip rolls out or leaks.
CAUSE: Pressure in drainback passage to sump.

SOLUTION: 1. Drill with 9/32" or 5/16" drill.
2. Enlarge drainback passage.

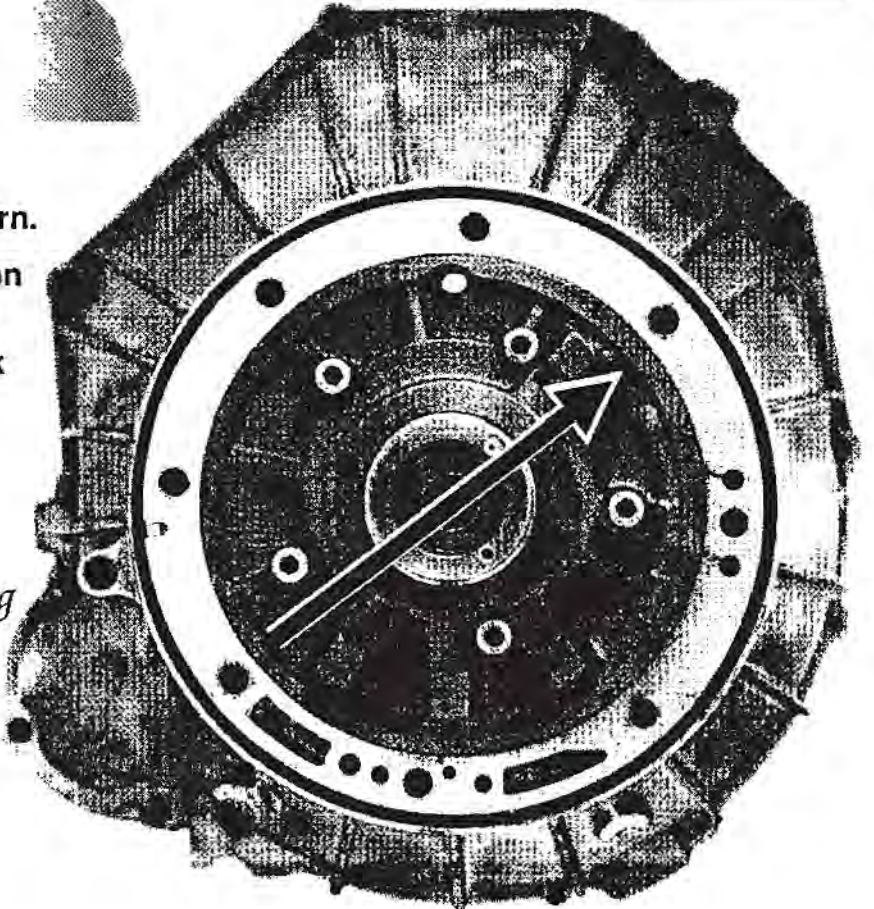
Bell Housing Bushing: When reusing the original converter, or installing a converter that you are sure has a hardened hub, reuse the original bronze bushing (provided the clearance is under .006). When installing a rebuilt with a soft hub you must use a babbitt bushing. When replacing bushing, stake the the bore in front of bushing to keep it from moving forward into seal. Replacment bushings are often looser than the original bushing. **You don't need pump whine or broken pump gears, so don't forget to align the pump as shown below.**

Best way w/o aligning tool:
Install pump & back bolts off 1/2 turn.
Install converter into bell housing.
Install bell housing and converter on engine and tighten with four bolts.
Install flex plate bolts.
Hold pump firmly towards 2 o'clock (as shown in picture) and finger tighten the bolts.
Then tighten evenly with wrench.
