RE4F02A & RL4F02A Shift Kit[®] With Hi-Temp Low-Shrink Sealing Rings This kit is about

SK RE4F02A[®]

Maxima: 1985-96
Pulsar: 1988-90
Stanza: 1986-92

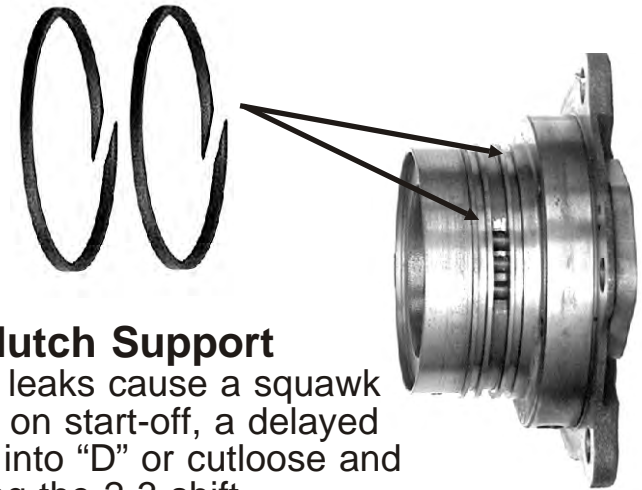
Forward Clutch Support

Forward ring leaks cause a squawk or a shudder on start-off, a delayed engagement into "D" or cutloose and squawk during the 2-3 shift. You just fixed it.

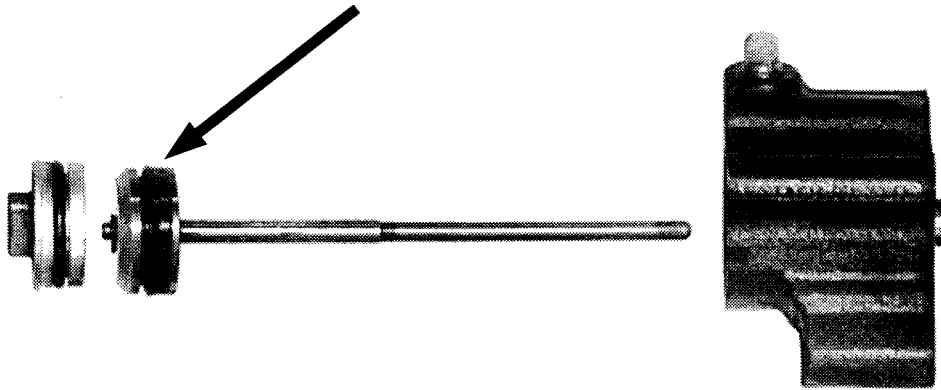
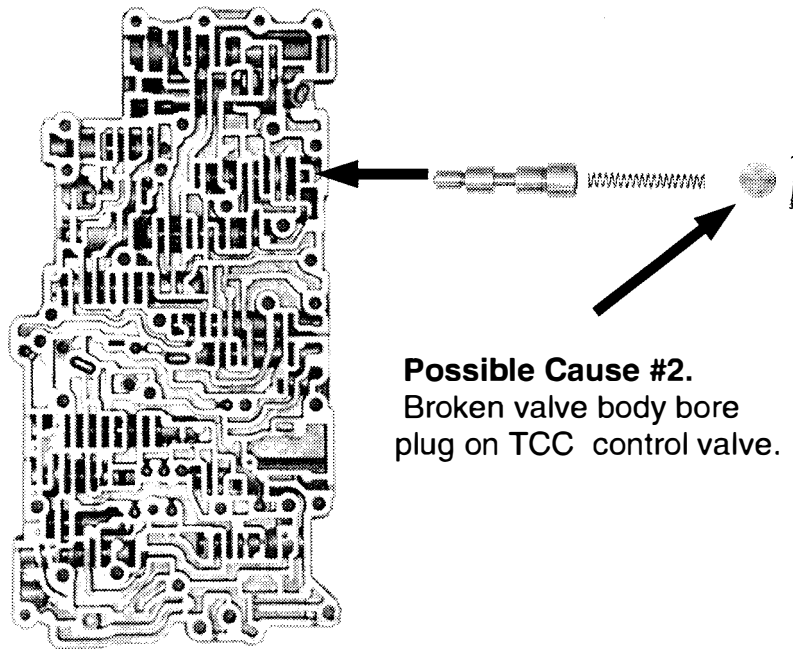
Possible Cause #1. Control cylinder rubber seal hard/flat/shrunken. Commonly the cause if the complaint is "cold only" and the unit is a high mileage original job.

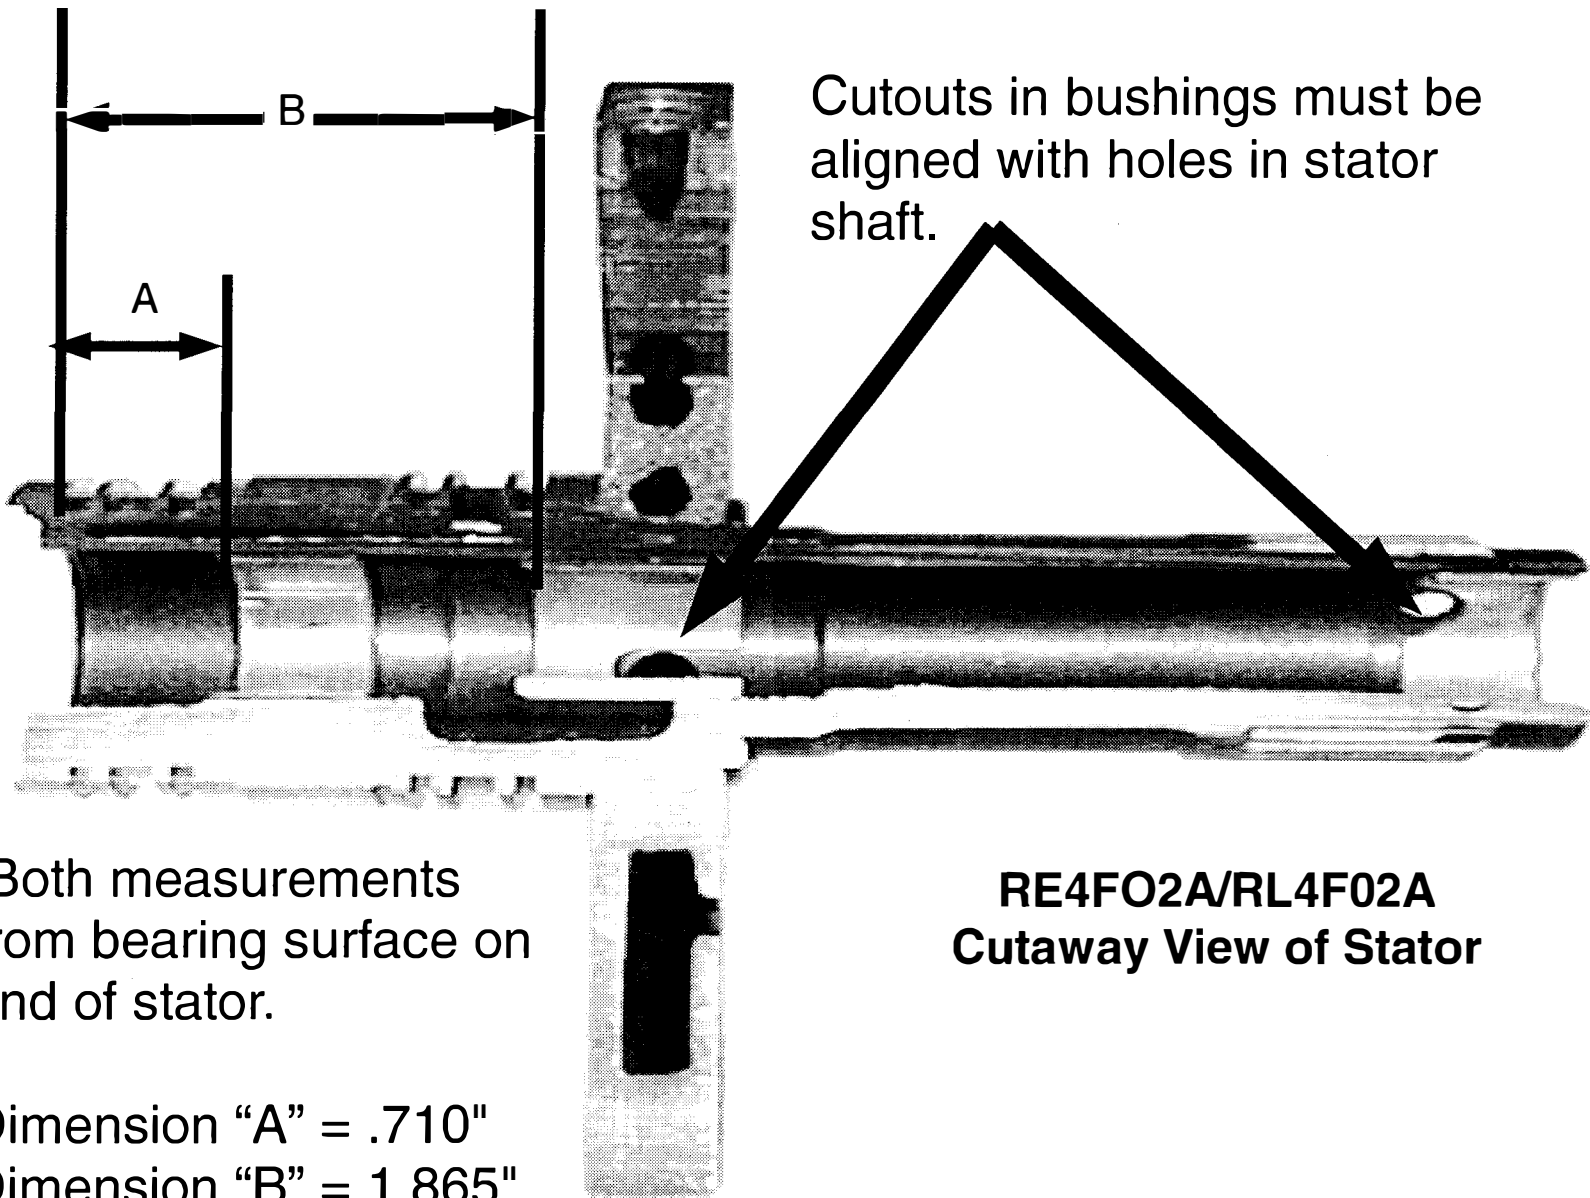
**RE4FO2A/RL4F02A
Cutaway View of Stator**

Possible Cause #2.
Broken valve body bore
plug on TCC control valve.

Cutouts in bushings must be aligned with holes in stator shaft.

Both measurements from bearing surface on end of stator.

Dimension "A" = .710"
Dimension "B" = 1.865"

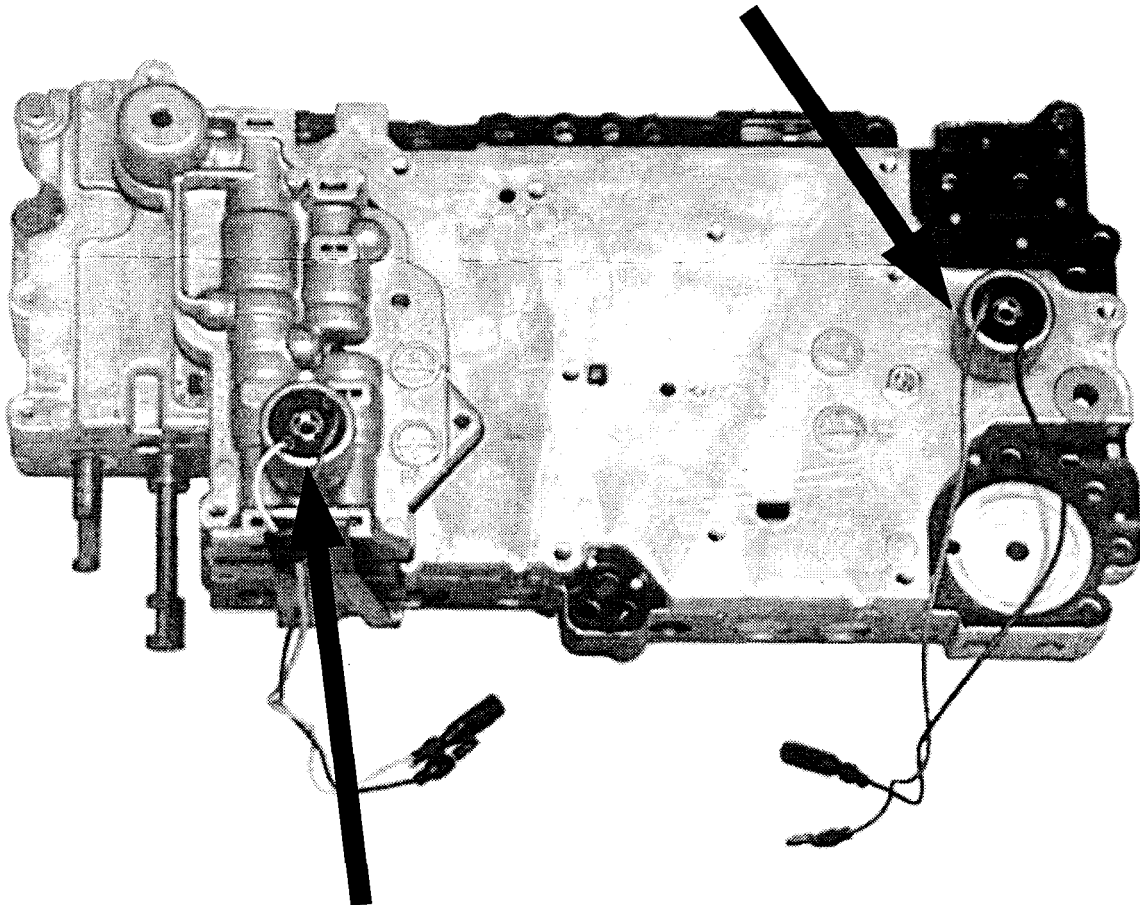
A complaint of falls out of 4th gear EXCEPT on lift throttle may be experienced after overhaul or valve body service. The transaxle may shift into 4th only when the throttle is released, then downshift to 3rd as the throttle is applied. Another related symptom may be abnormal TCC apply/release. One cause of these complaints may be the TCC and OD Cancel solenoids installed into the wrong positions on the valve body. Solenoids must be installed as shown below.

The correct locations and wire color codes are shown in the picture below.

The OD Cancel Solenoid installs here. Wires are Black and Red.

The TCC Solenoid installs here. Wires are Blue and White.

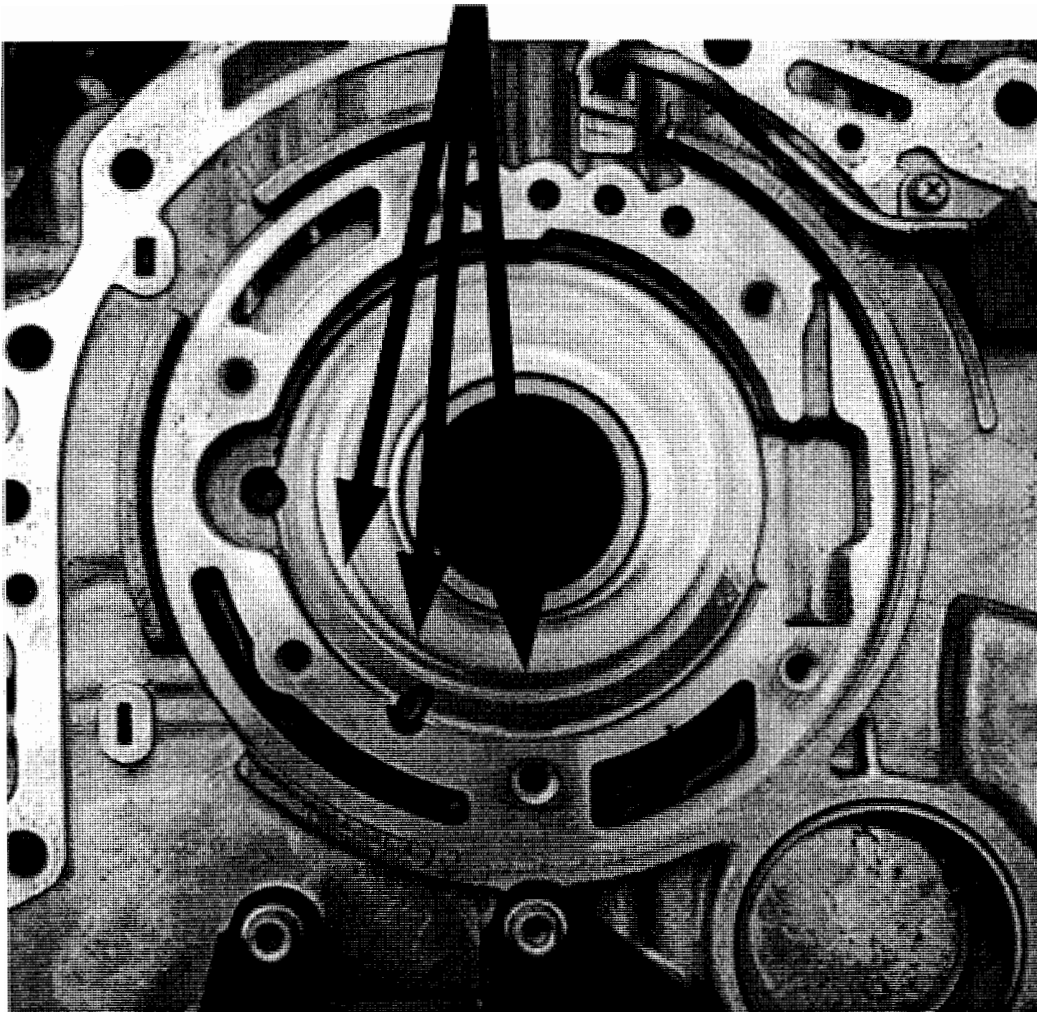
Pump Pocket Wear

It is normal for a certain amount of pump pocket wear to occur over time on these units. The wear is usually worse in the location opposite the slide spring. Some shops are having the cases machined and resetting geartrain endplay by replacing the selective washers. This is a satisfactory repair if done correctly. However, there have been some incidences of mismachined pockets that result in line pressure problems after reassembly.

While this wear is not technically correct, it has not been proven to create any operational or durability concerns either. The complaints and failures these units come in for are almost **NEVER** a result of this pump pocket wear.

Pump pocket wear here is not a major concern. It does not require a new/repaired case to provide a durable rebuilt unit.
