# Installation Instructions for '94 - '02 Dodge Trucks

## Part # 000945, 000950

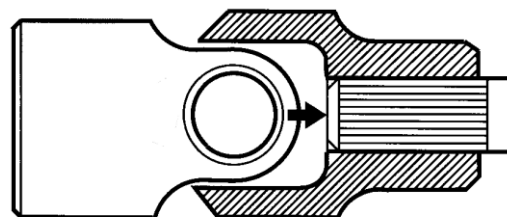
FIGURE A

4. For splined connections at the box or column a seat must be provided for the set screw as shown in Figure A. (**NOTE** The existing factory flat will not be used) Tighten the set screw to mark the shaft and then remove the universal joint to file a new flat spot on the splined shaft. Tighten the set screw into the seat and then tighten the lock nut.

3. Fully collapse the Borgeson shaft assembly and fit into position. Now extend the shaft length so that the ends fit over the splined or "DD" shafts at the steering box and steering column to the depth shown in Figure B below.

5. For Double-D connections at the column a small dimple should be drilled into the shaft at the set screw locations to insure proper seating of the set screws. First install the universal joint to the depth shown in Figure B and mark set screw locations. Remove universal joint from column shaft and drill a small dimple into shaft at locations marked. Reinstall universal joint to depth shown in figure B. Tighten the set screws into the seat and then tighten the lock nuts.
