SK[®] A246

Corrects/Prevents/Reduces

Shuttle, bind-up or flare on 2-3 shift, slips with throttle in 3rd and/or 4th, chugs/kills engine at a stop, TCC slip codes.

Toyota: A246E 4 speed:

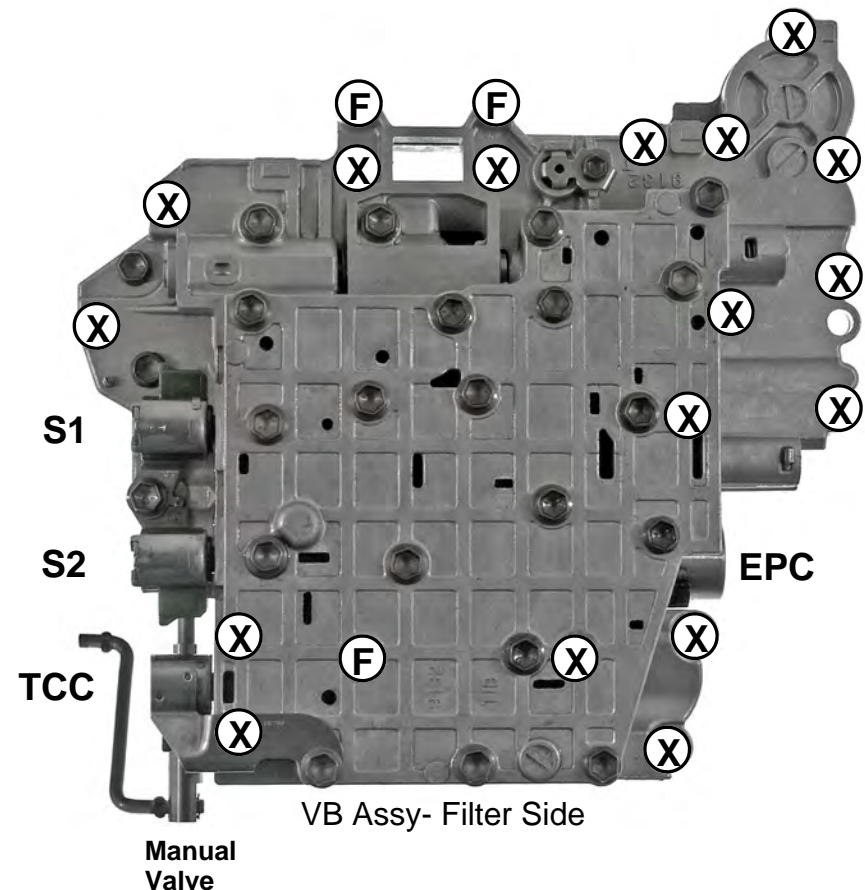
Step 1

Remove the "F" filter bolts then the "X" bolts that hold the VB to the case. Disconnect wiring. Un-hook manual valve. Keep bolts separate from the rest of the VB bolts.

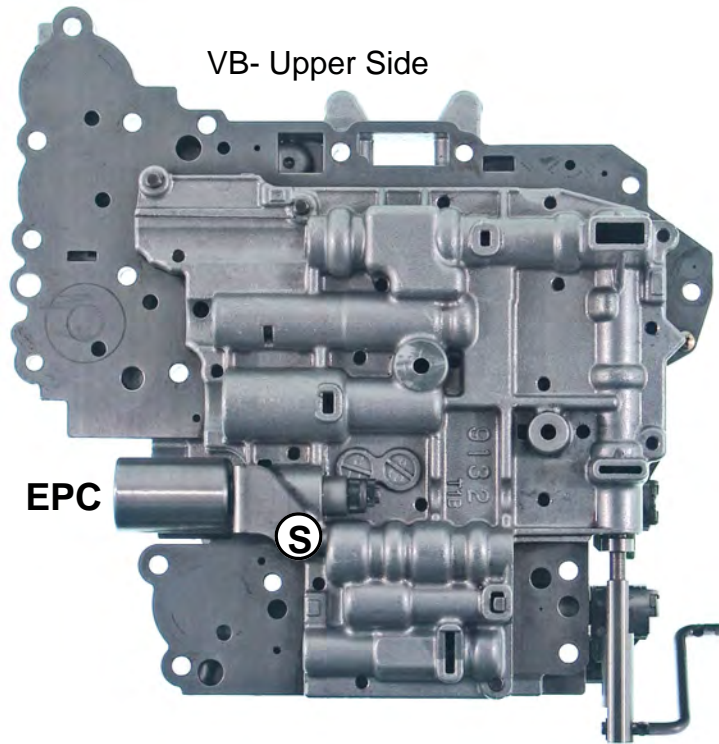
Step 1

Remove EPC Sol "S" bolt and EPC Sol. as shown at left. Flip VB over so the filter side is facing up as shown below. Remove the "S" bolts holding the solenoids in first. After removing the solenoids, remove the bolts marked with an "X" only! The "Y" bolts hold the bottom cover plate.

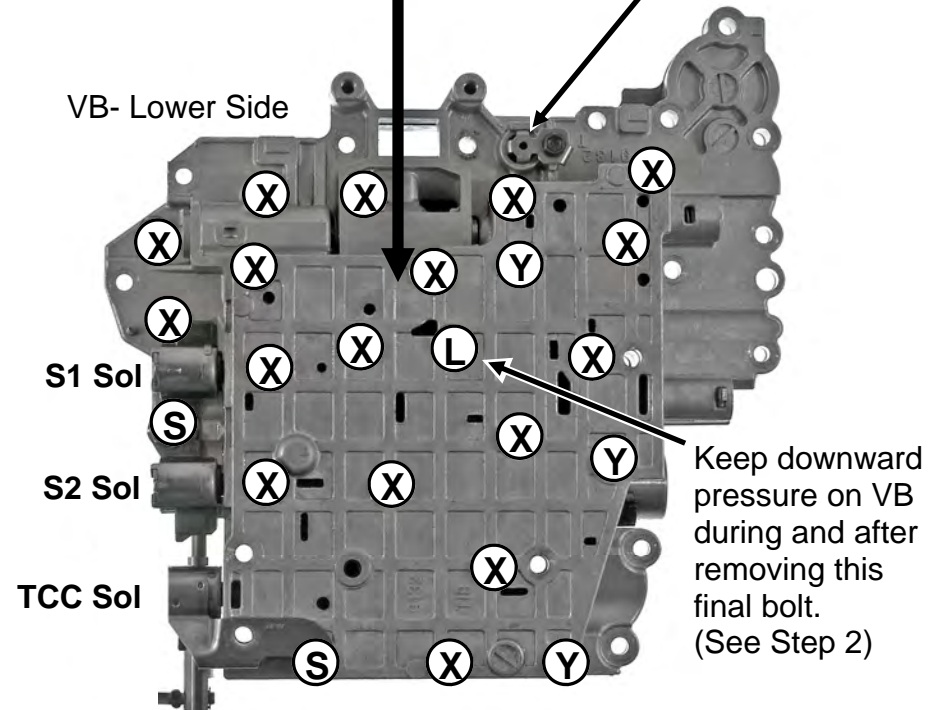
Step 2

After removing the "X" bolts, hold downward pressure on the body while removing the **final "L" bolt**. Lift the lower body **AND the separator plate** together as an assembly off the upper body. Squeeze the plate and the body together as you lift it off. (The cooler relief valve has pressure on the plate.) Flip the Lower VB assembly over with separator plate facing up at you. Remove plate and mark the locations of all small parts on both VB halves. Mark the locations of check balls, filters, relief valves and retainers just in case they differ from what is shown in this instruction. Always reinstall them back in their original locations.

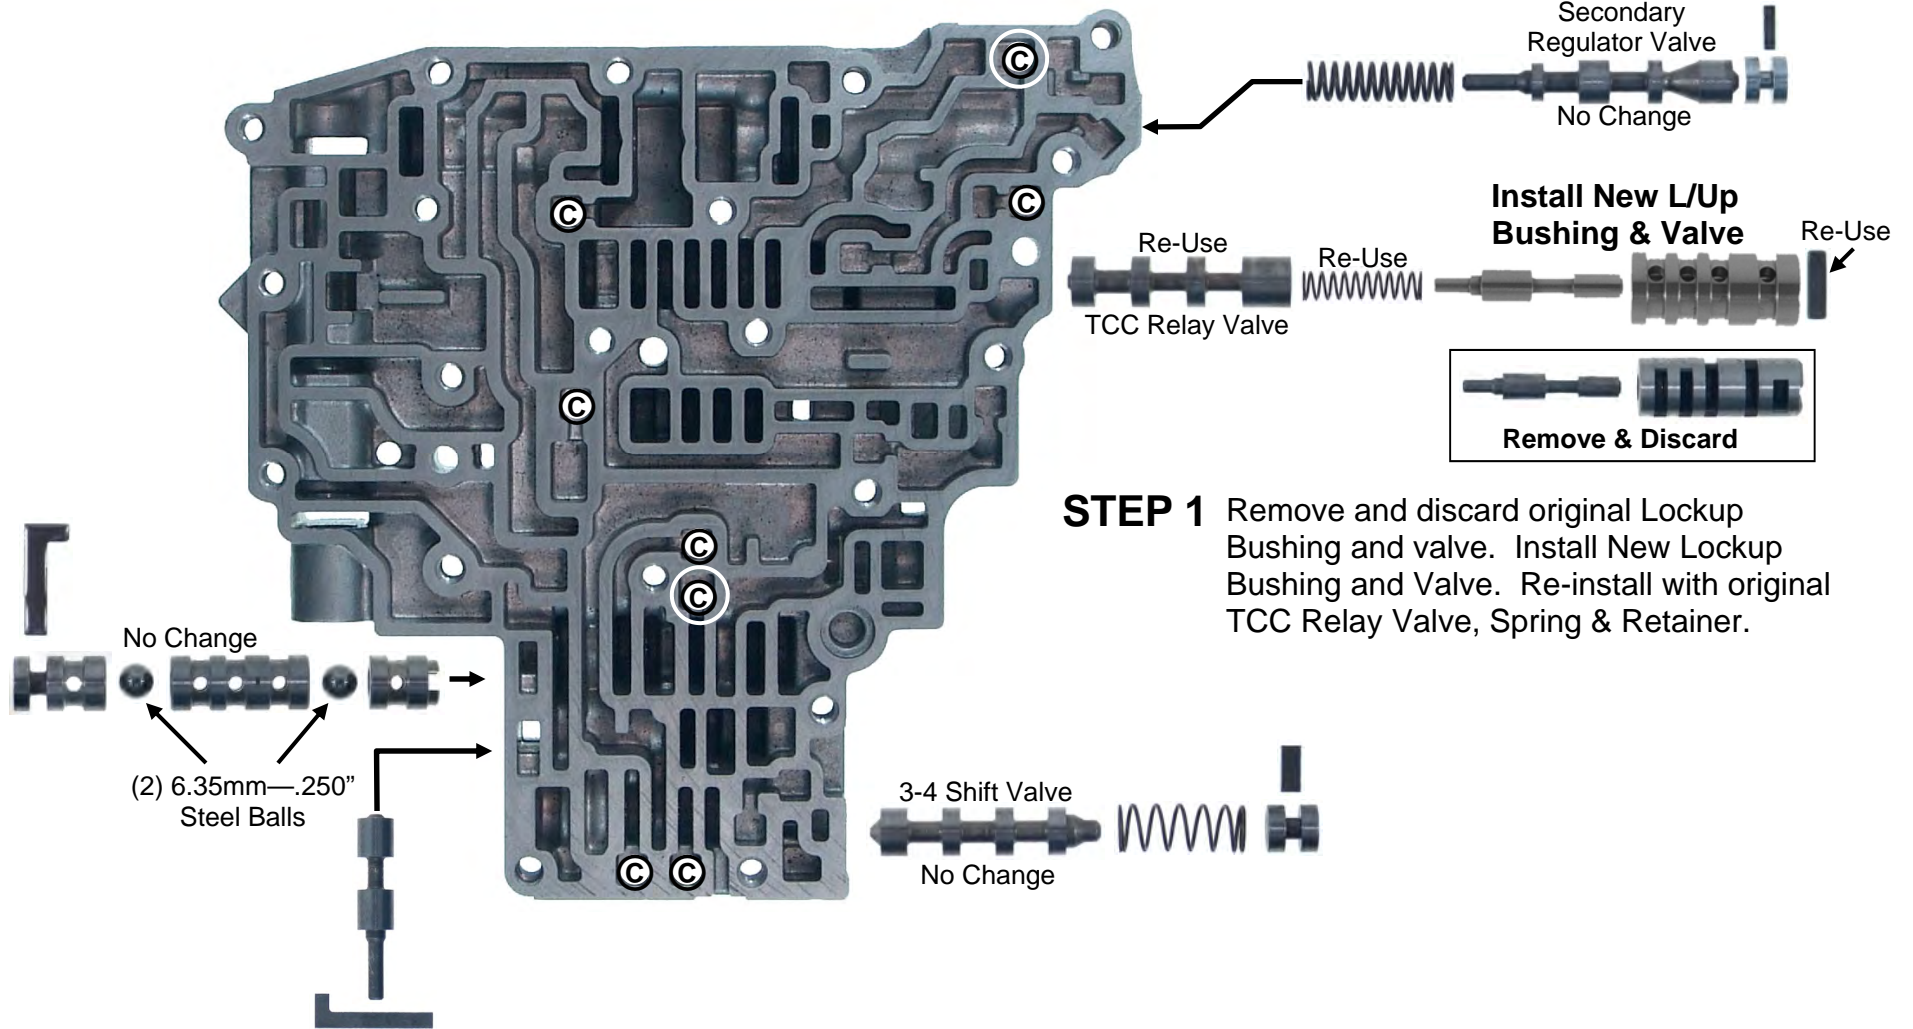
Upper Valve Body Repairs

- © (6) 5.50mm—.217" Plastic Balls
- © (2) 6.35mm—.250" Plastic Balls

STEP 1 Remove and discard original Lockup Bushing and valve. Install New Lockup Bushing and Valve. Re-install with original TCC Relay Valve, Spring & Retainer.

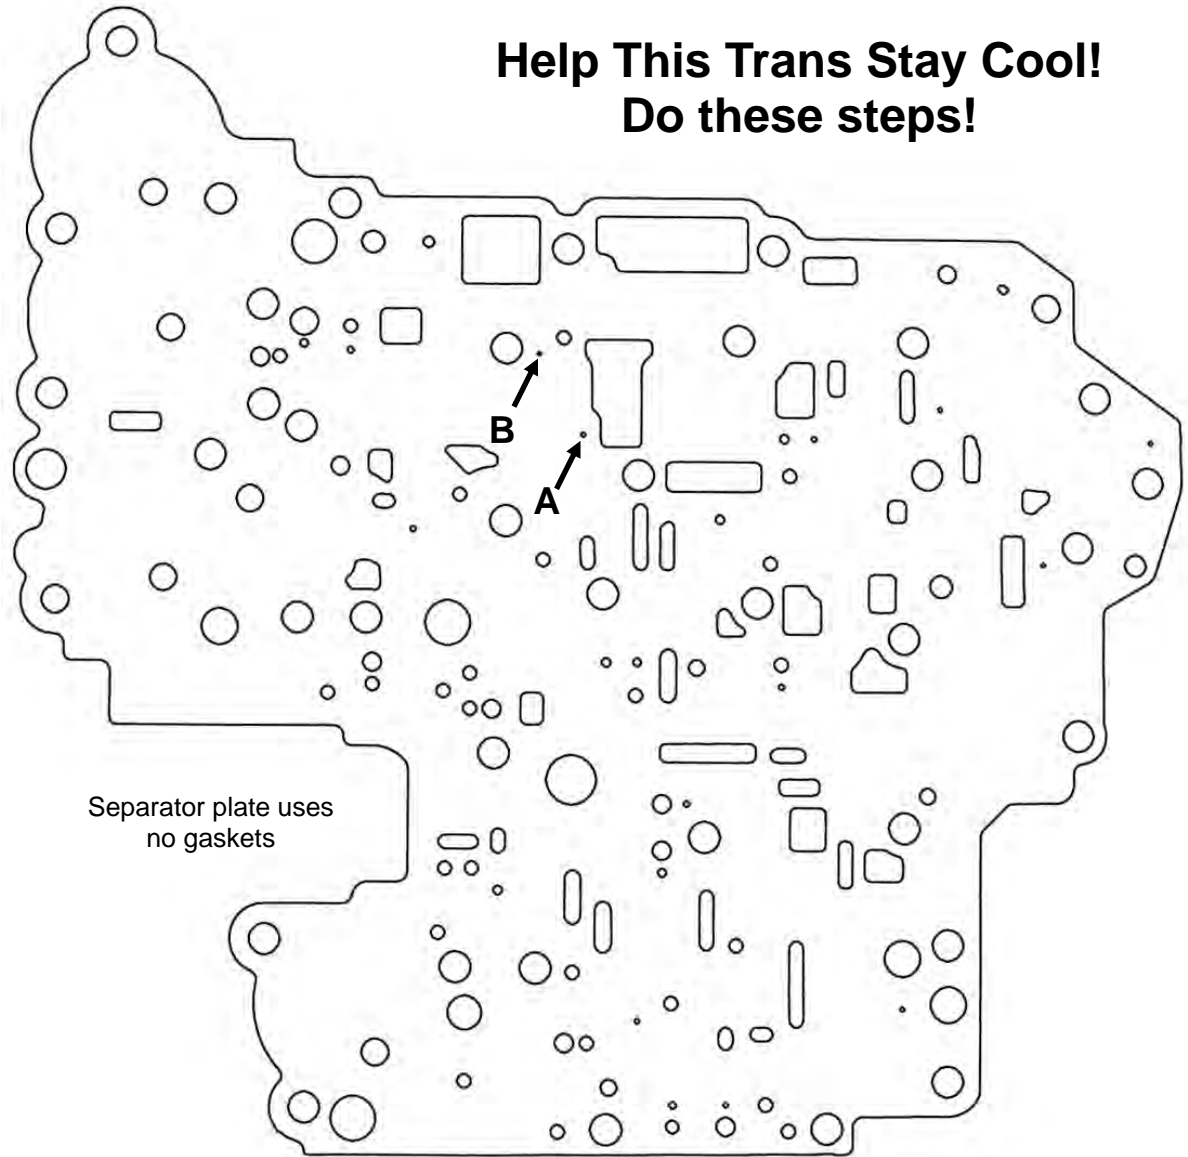
Lube Corrections

Enlarge main separator plate holes A & B with .055 drill provided.

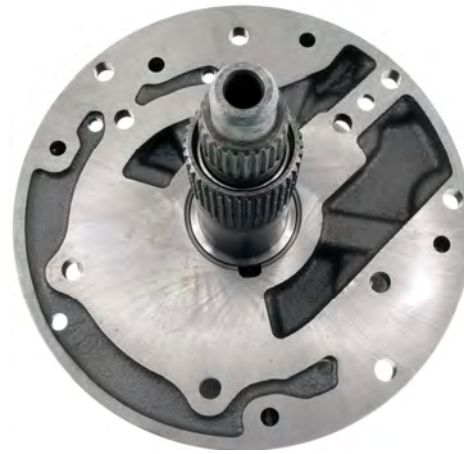
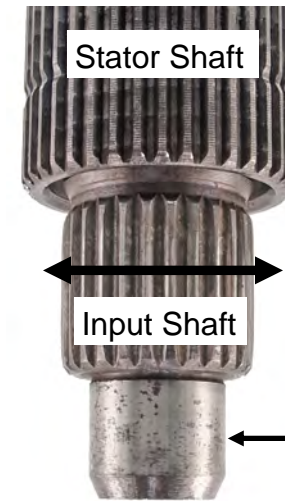
While the trans is apart, use extra focus and check the condition of the front stator bushing in particular as well as the rear bearing that supports the input shaft.

The more “wobble” the shaft has, the more leak you have in apply oil. The front stator bushing is a barrier between converter rear oil and converter front oil. Mixing the two circuits causes loss of apply pressure on the converter rear circuit during Lock-Up apply.

Very little to no “wobble” is best!

Pitted/Rusty shaft here is a NO-NO! Wears out seal!

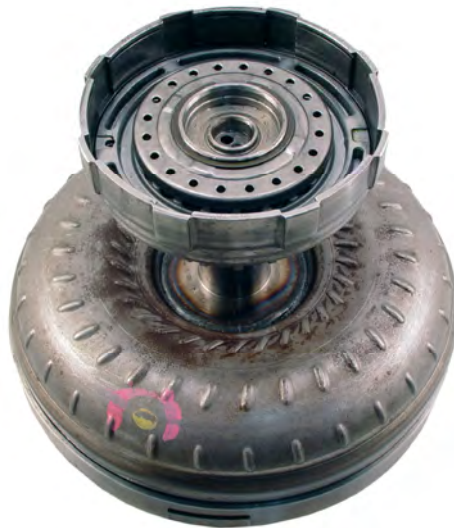
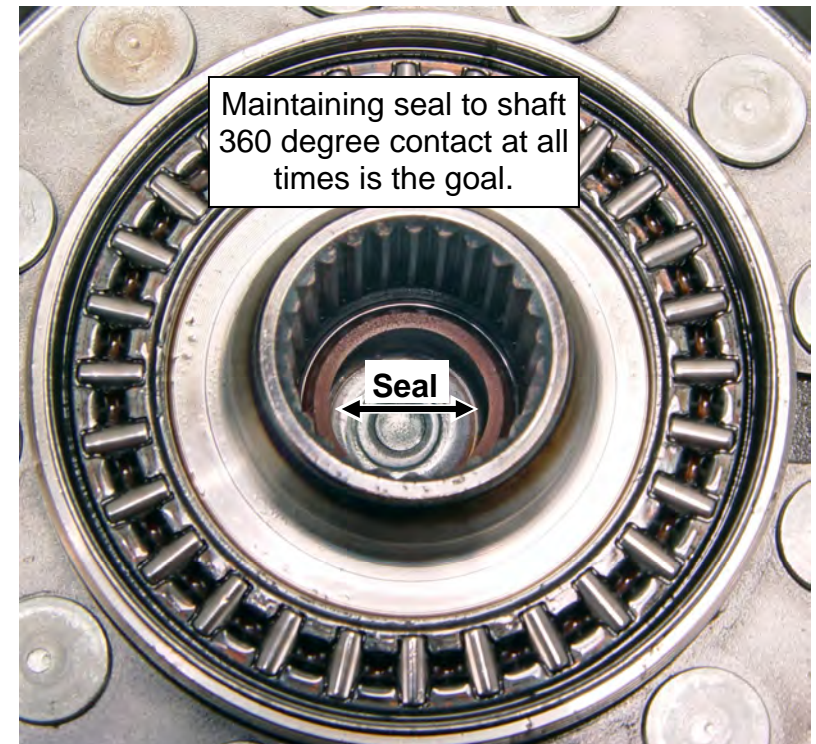
Always insert the input shaft into the converter till it bottoms out. Lift the drum up gently and you'll feel the seal lightly dragging on the shaft which feels different from the spline drag. No feel? Look into converter and inspect the seal. The shaft must have drag on the seal or you risk a TCC performance issue!
