RE4F02A & RL4F02A Shift Kit[®] With Hi-Temp Low-Shrink Sealing Rings This kit is about

SK RE4F02A[®]

Maxima: 1985-96
Pulsar: 1988-90
Stanza: 1986-92

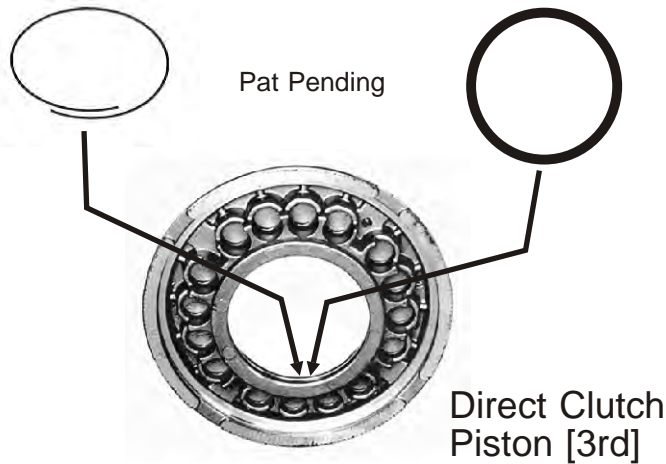
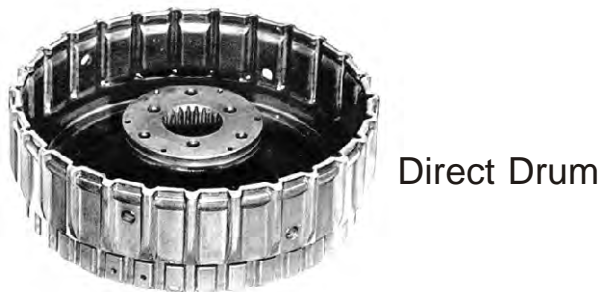
Inner Direct Piston Seal

On the road original seal would get hot and soft, the centrifugal force expands it outward into the piston so it wont seal after 3-2 or 4-2 kickdown. The compression spring constantly makes seal tight by cancelling centrifugal force. The harder seal resists wear even if the drum is not smooth.

A. Insert the overlap part of the wire into groove at 6 o'clock.

B. Start the solid seal into the groove at 6 o'clock.

Install **RINGS** with some assembly-Jel. Ends of ring should just touch or have a small gap. If pushed together **FIRMLY** they may **BIND** in the groove and **WON'T SEAL**. Be *GENTLE*, OK. **HOW TO AIR CHECK:** Pump 10-12 squirts of fluid into the feed circuit and apply with full shop pressure. Then reduce to 30-40 psi and recheck apply.
