**EXAMPLES OF DAMAGE CAUSED BY TOP FRAME ISSUES**

**THESE ISSUES ARE NOT ELIGIBLE FOR "DEFECTIVE ITEM" CLAIMS OR COVERED BY OUR WARRANTY**

**ARO PATTERN #259 1968-72 GM A-BODY CONVERTIBLES**

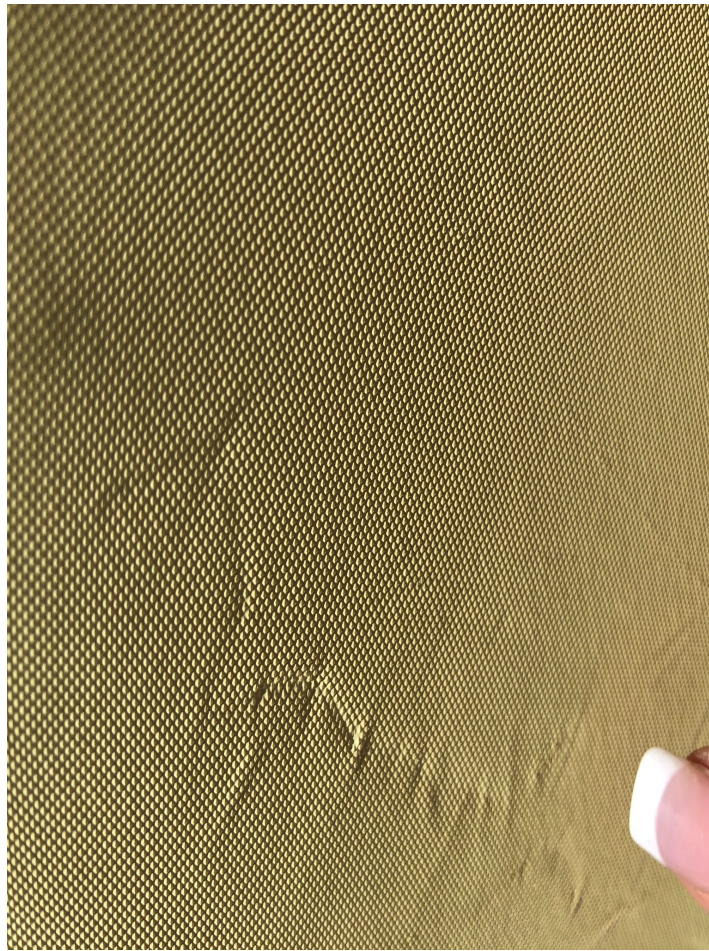
***THE TOP WAS FINISHED ACROSS THE FRONT BEFORE THE WIREON TRIM WAS INSTALLED - PULLING THE CENTER OF THE VALANCE TOO FAR FORWARD. THE REAR DECK SHOULD HAVE HAD A FEW STAPLES ACROSS THE REAR BOW TO POSITION THE VALANCE PROPERLY BEFORE FINISHING THE FRONT.***
