SK® U760E

For Professional Use Only! Shuttle Shift, Flair on 2-3 Shift, Slips with throttle in 3rd and/or 4th, TCC Slip codes.

Toyota: U760 6 speed:

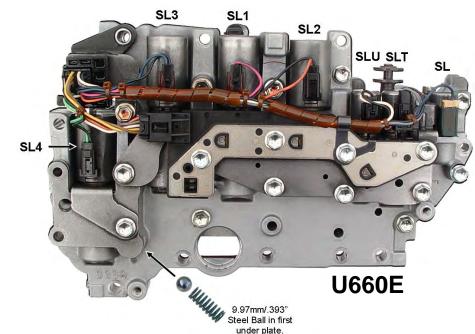
Tech Note:

Always mark the current locations of check balls, retainers etc. to insure they are returned to their original locations even if they differ from what is shown. This is a typical layout of these valve body's. Use care in disassembling.

Planetary failure always REQUIRES a complete strip and cleaning of the valve-body!

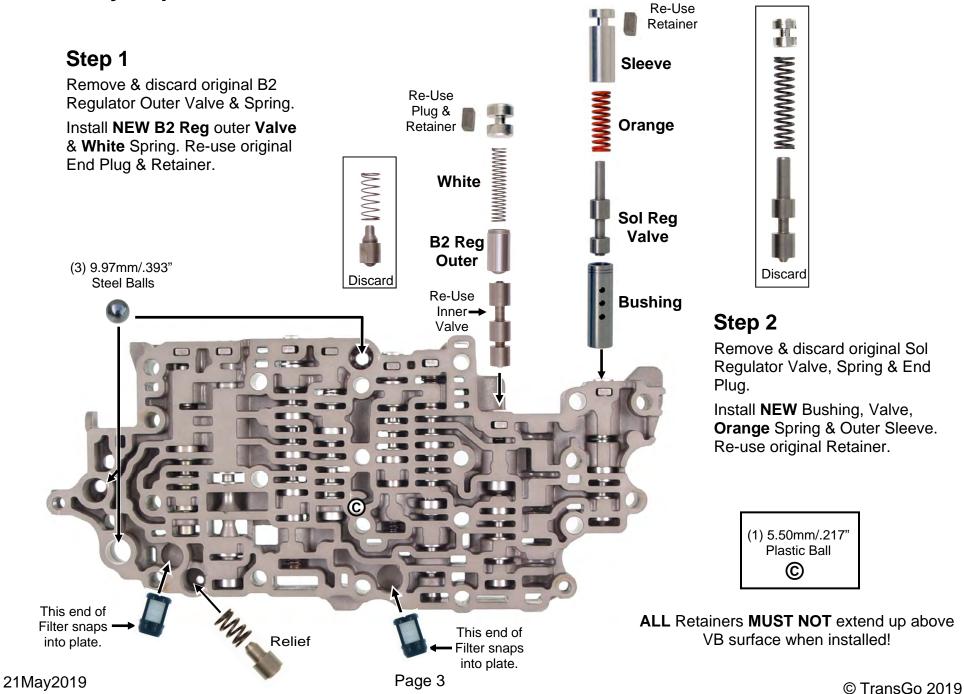
Mid-Body Repairs

Pay Attention to Small
